## LEBANON REFORESTATION INITIATIVE

# OUTPLANTING MONITORING AND INSPECTION PRACTICES AND RESULTS

This technical report is developed by the Lebanon Reforestation Initiative – Outplanting component. It includes the results of 4 years of reforestation work across Lebanon, from October 2011 till the end of December 2014.

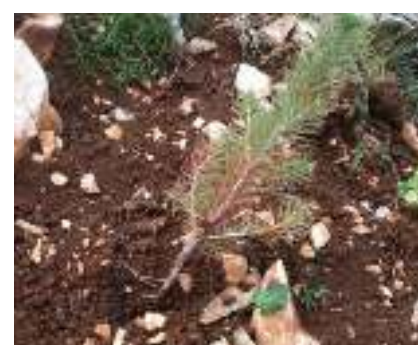
*Figure 4. Example of a planted seedlings that is both bent and too shallow (notice upper roots exposed above soil level)*

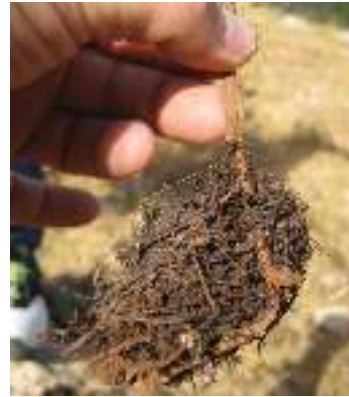
*Figure 6. Example of a J-rooted seedling*

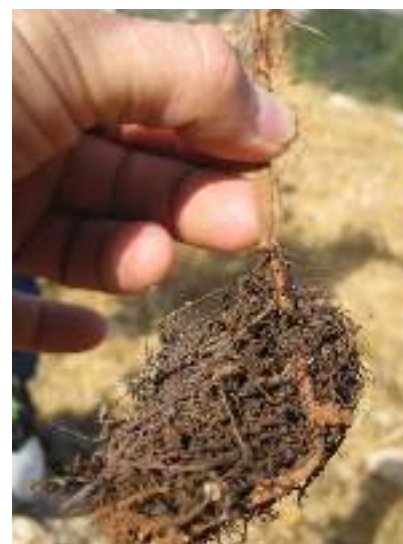
Because inspections were not done during the 2011 planting season, no data is available. However, j-rooting (Fig. 1-1) and shallow planting were noted during site visits. The limited experience of the planting crew, combined with extremely rocky conditions, resulted in poor planting, which in turn contributed to poor seedling survival.

Figure 1-1. J-rooted seedling removed from Aanjar site in summer 2012

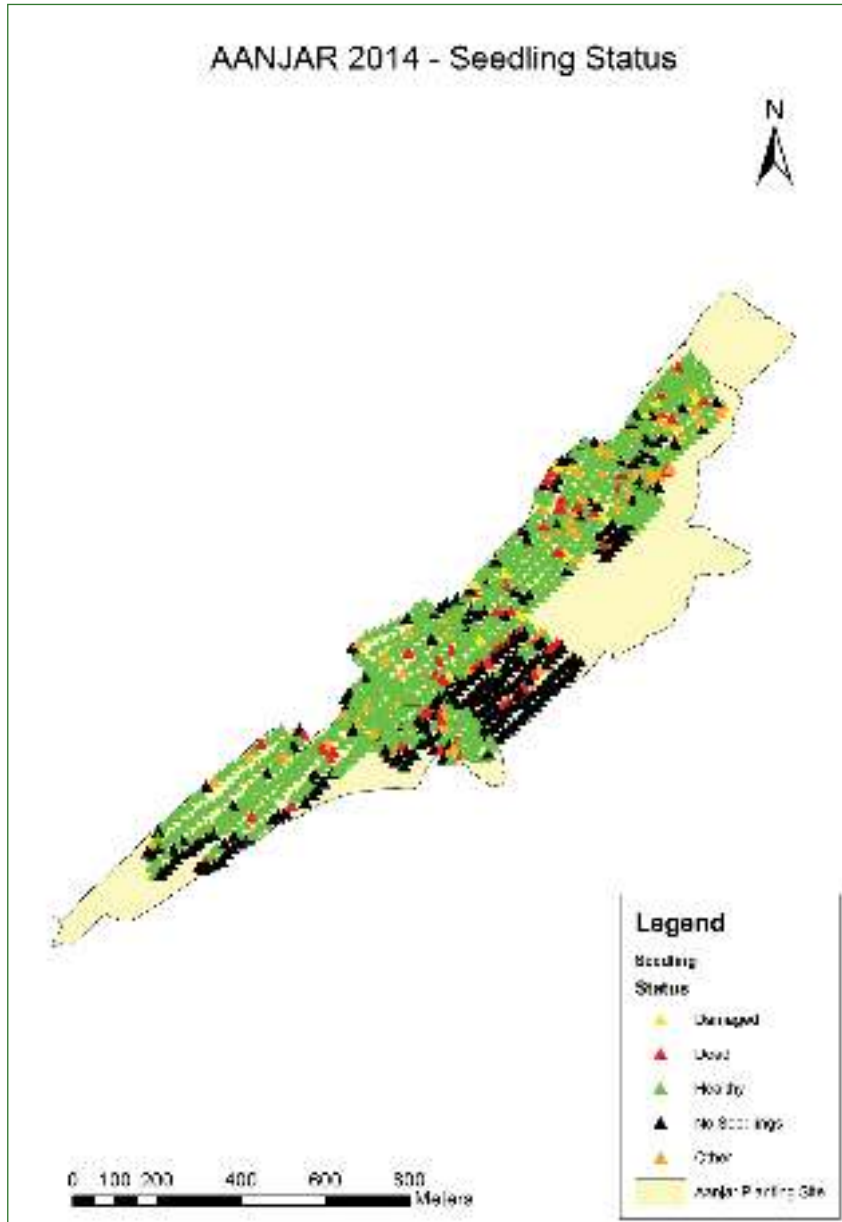
Only one area at the edge of the site was left without irrigation for trial purposes and seedlings planted above the irrigation system were irrigated only once. As shown in figure 1-7 below, mortality in 2013 was mostly concentrated in those two areas, which reflects the high effect of moisture in seedling survival.

Figure 1-7. Seedling status map of Aanjjar reforestation site based on the yearly monitoring data - summer 2014

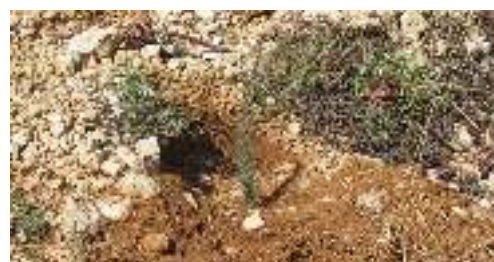
Worker performance was also relatively high. The relatively low value of 57.58% of the below-ground planting quality was mostly due to the presence of gravel in the planting hole. However, the Ainata site soil is full of gravel and it is almost impossible to have a planting hole with clean soil (Fig. 2-1).

Figure 2-1. Cedar seedling planted in Ainata – fall 2012. Photo shows the amount of gravel in the soil

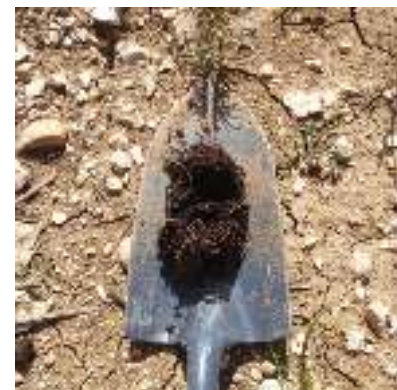
Figure 4-1. Cedar seedling roots damaged by inadequate packing and transportation

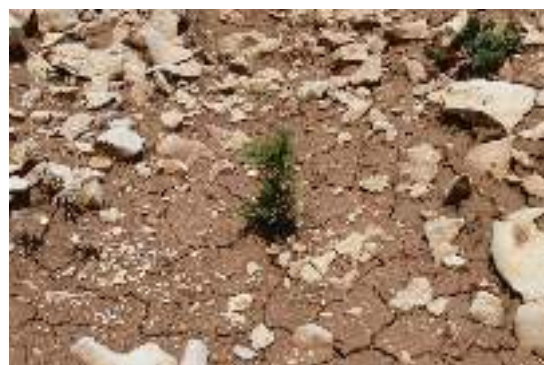
Figure 4-4. Cedar seedling surviving the drought. Photo taken in late May 2013 shows soil cracking due to drought

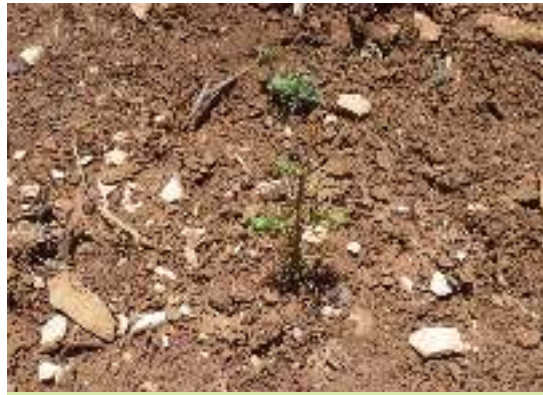
Figure 4-5. Cedar seedling showing signs of grazing – Kfardebiane - June 2013

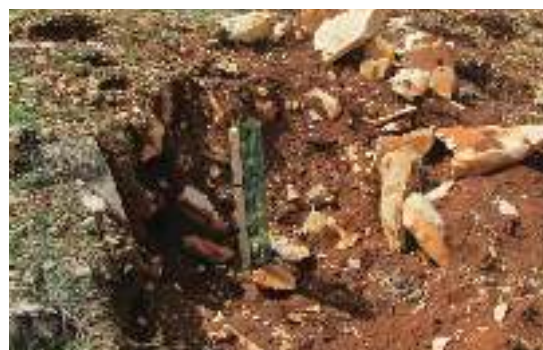
Figure 5-1. Seedling planted in 2011 in Kfarzabad in a deep hole full of large rocks

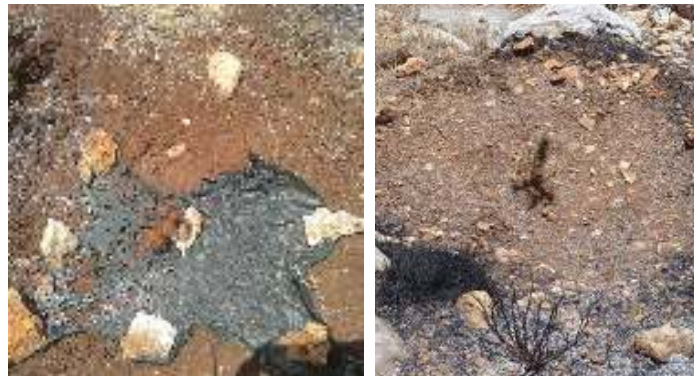
Figure 9-6. Photos taken in Rmadiye on July 9th, 2013 showing the contrast in the effect of fire on a seedling surrounded by a plastic mulch mat (left) with a seedling around which weeds were scalped (right)

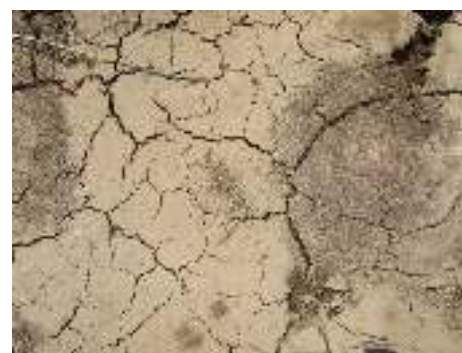
Figure 10-1. Photo taken in Tannourine planting site - May 15th, 2012 - showing a dead seedling and deep cracking of the soil around it
