DEMOLITION WASTE ASSESSMENT

OUTSIDE THE PORT OF BEIRUT

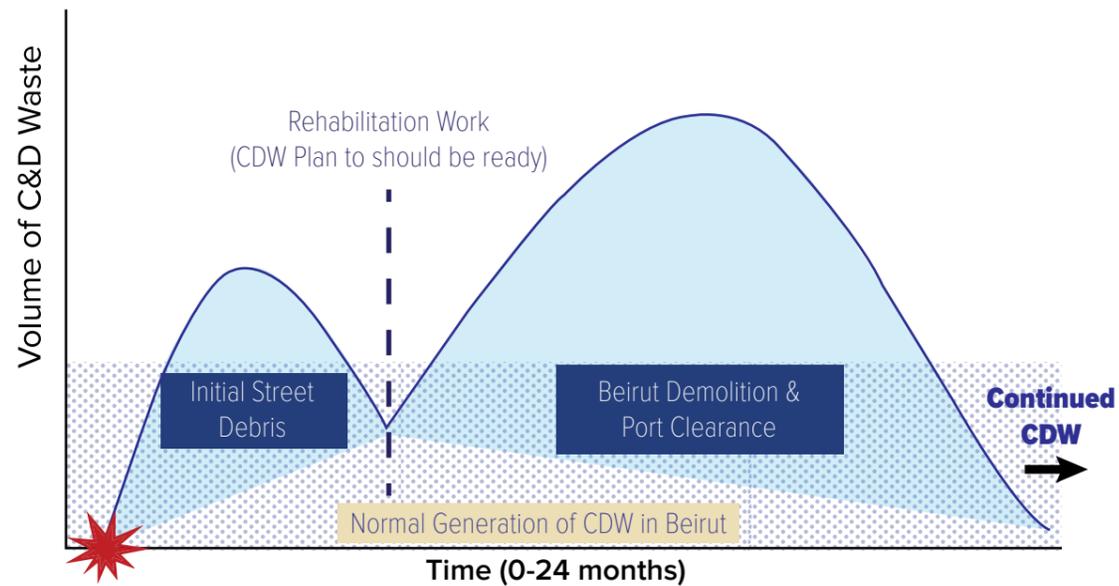
Figure 1. Amount of Construction and Demolition Waste Over Time

The main objective of this assessment is to support the design of an environmentally sound and cost-effective waste management plan by identification and quantification of the disaster waste from the Beirut Blast. From past experience, the volume of disaster waste is expected to increase over time due to the waste from construction and demolition during recovery and reconstruction activities (Figure 1).

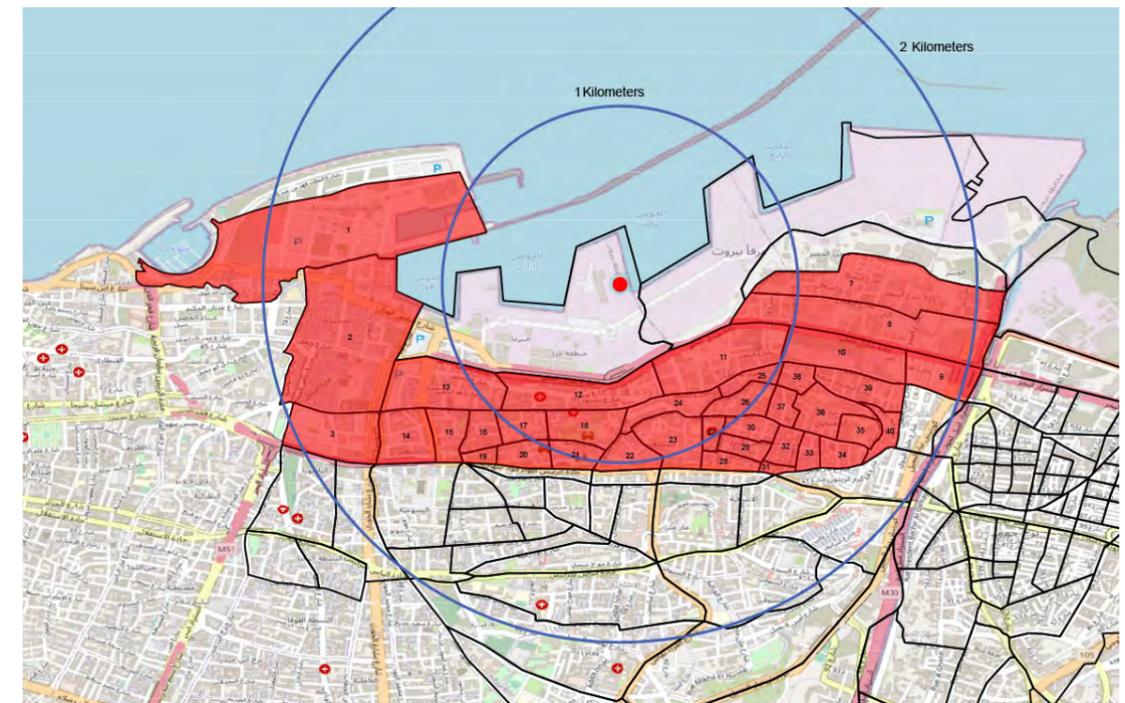
Figure 2. Map of Red Zone in Beirut.

The survey was initiated on 15 August 2020. The damaged areas in Beirut and Mount Lebanon were divided into 139 zones based on the delineation set by the Lebanese Armed Forces (LAF) and commonly used among the humanitarian and international agencies in the response². 36 zones located within an approximate 2 km radius of ground zero of the Beirut blast were considered to be the “Red Zone” for this assessment based on the initial observation of the building damage in Beirut (**Figure 2**)³. In line with this observation, the subsequent assessment by UN-HABITAT (see section for Comparative Analysis) revealed that there were only minor and no structural damage to buildings outside of the Red Zone, even though windows and doors were damaged in the broader area. Thus, it was assumed that the quantification of construction and demolition waste (CDW) within the Red Zone would provide a reasonable estimation of the potential volume of overall CDW from the blast. More details can be found in the **Annex 2**.

By the end of September, over 700 buildings in the red zone were inspected by the engineers to assess damages on

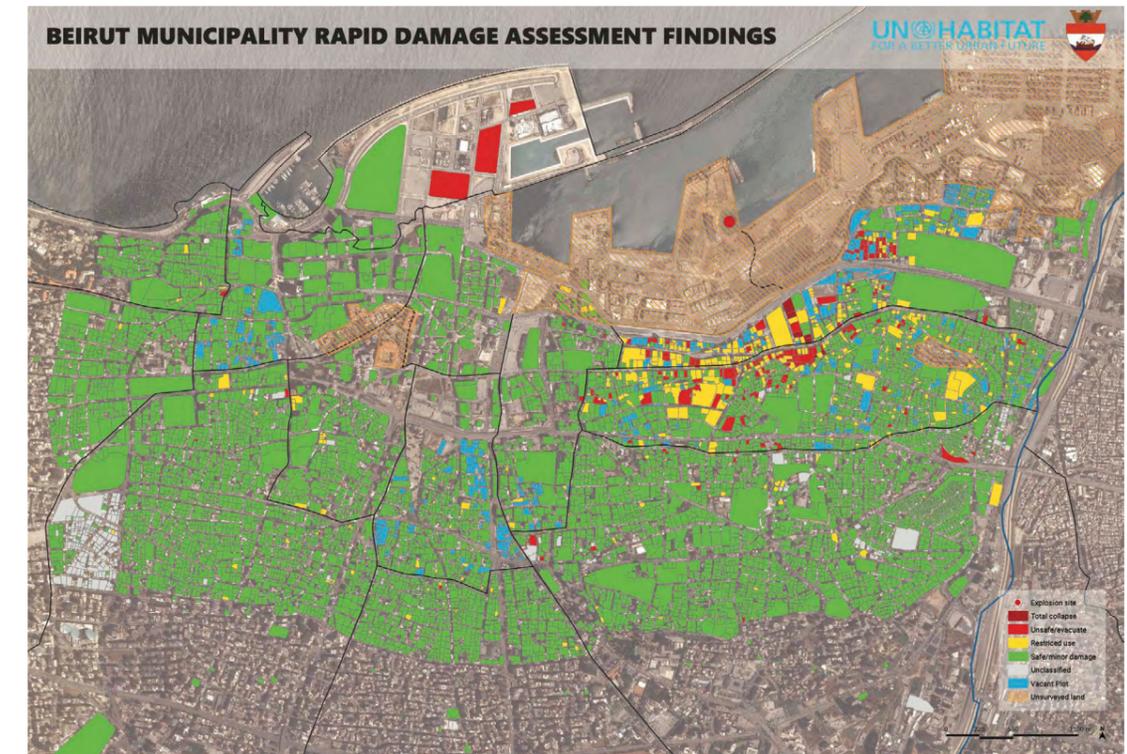
Figure 3. Rapid Damages Assessment by UN-HABITAT and Beirut Municipality.

UN HABITAT and Beirut Municipality conducted an exhaustive rapid damage assessment in order to identify buildings that have collapsed, those that were severely affected, or had minor impact within the administrative zone of Beirut. The field survey was conducted by volunteers supervised by municipal engineers and private engineering companies. As depicted through **Figure 3**, the severely damaged and destroyed buildings are largely located in close proximity to ground zero, within the Red Zone. Thus, the estimation of CDW only within the Red Zone is expected to generate realistic value.

UN-HABITAT's assessment also implied that several zones within the Red Zone might not have significant damage (total collapse, unsafe/evacuate category, but could have minor damage) as shown in green in **Figure 2**. Taking this into account the estimation with linear regression was carried out by removing buildings within these zones from calculation for the sake of comparative analysis (**Figure 4**)⁴. Using the same linear regression, the estimated amount of CDW based on this assumption is as follows:

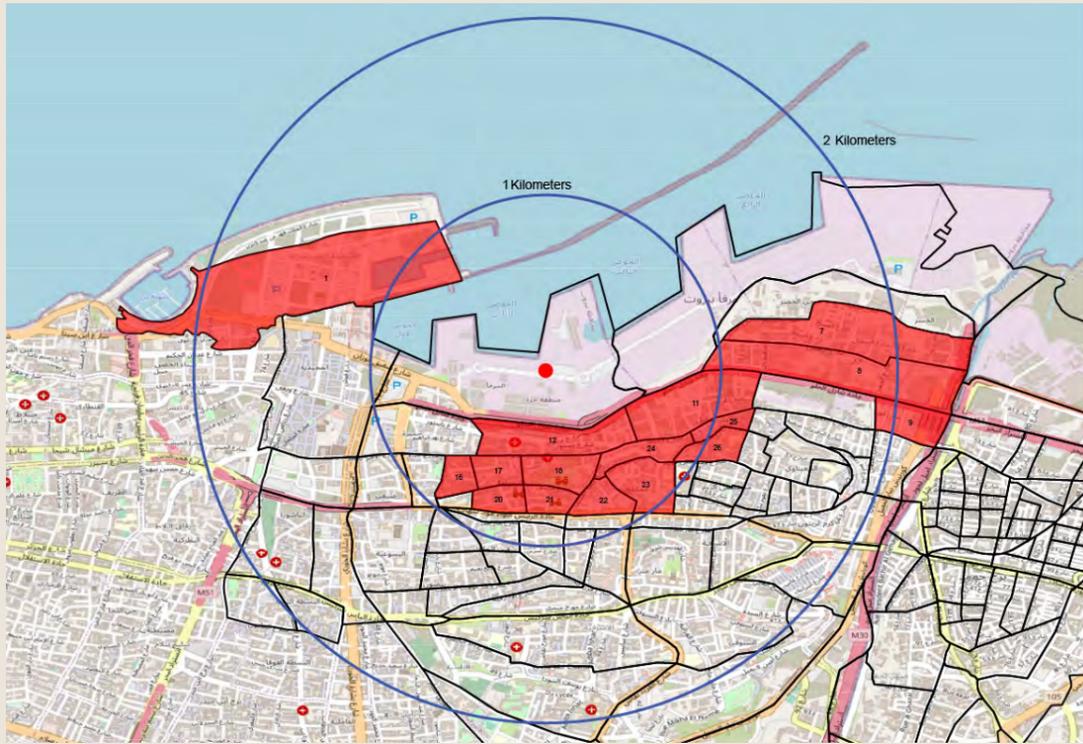
Figure 4. Modified Red Zone for Comparative Analysis based on UN-Habitat's Assessment

4- The zones that were identified as mostly safe/minor damage in the assessment by UN-Habitat & Beirut Municipality: 2, 3, 10, 13, 14, 19, 27-34, 36, 37, 39, 40.

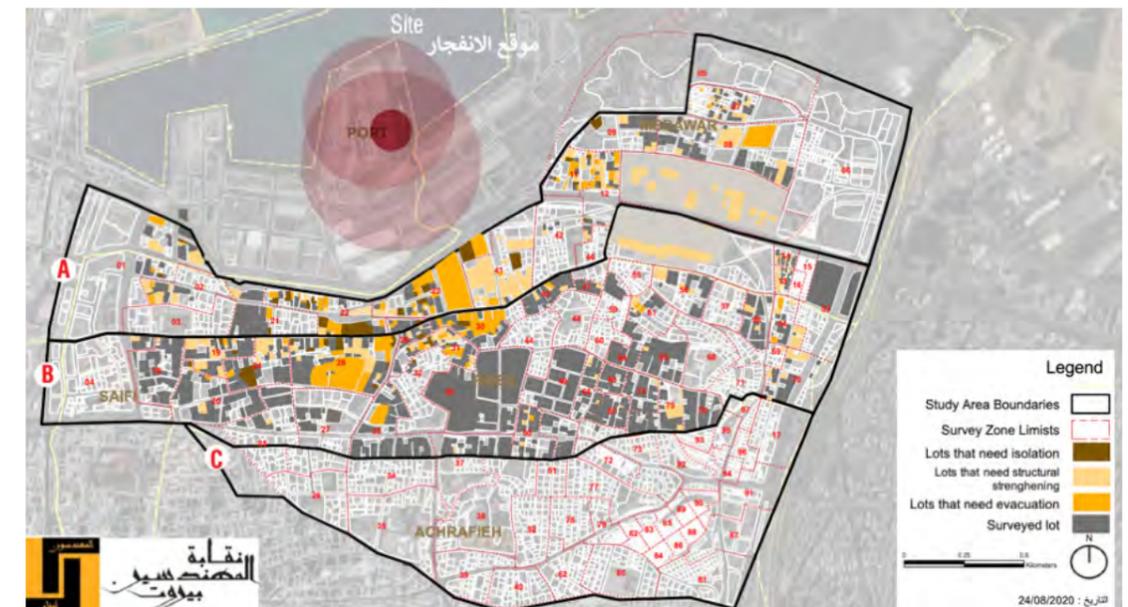
Figure 5. Building Assessment and Survey Zoning by OEA⁵.

The Order of Engineers and Architects (OEA) undertook a building damage assessment in order to produce recommendations for buildings that needed isolation for weather proofing, those that needed to be evacuated, as well as those that needed structural strengthening, whether immediate or onsite. As depicted by **Figure 5**, the OEA divided the affected area in Beirut into three zones (Zone A, B and C). The OEA's assessment does not measure the size of buildings since their objective was not to estimate the amount of CDW from demolition. Zones A and B nearly overlap with the Red Zone of UNDP's assessment.

By 31 August 2020, the OEA had surveyed 2,083 lots in total; out of which 30% of buildings are found in Zone A and 86% are found in Zone B. From the lots surveyed by OEA, 176 lots were classified as needing evacuation and 403 lots were considered as requiring structural strengthening, and 103 lots were classified in need of "isolation". Due to the lack of dimensional data of the buildings and different damage categorization, the quantification of CDW from OEA's assessment was not possible.
