## LEBANON REFORESTATION INITIATIVE

# OUTPLANTING MONITORING AND INSPECTION PRACTICES AND RESULTS

This technical report is developed by the Lebanon Reforestation Initiative – Outplanting component. It includes the results of 4 years of reforestation work across Lebanon, from October 2011 till the end of December 2014.

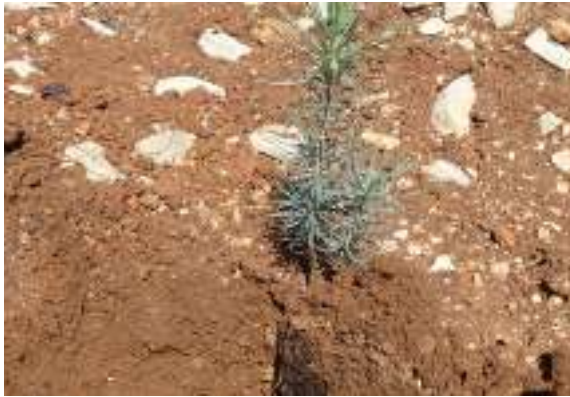
**Below-ground inspection** A subsample of seedlings in the plot are below-ground inspected by digging a hole with a small shovel to expose one complete side of the root plug without damaging the roots (Fig. 5). The inspector should then look for the following: i) if the root plug is straight, L-shaped or J-shaped; ii) if the soil is well pressed around the roots or if there are air pockets; iii) if debris and small stones are close to the root plug. Problems should be communicated to the planting supervisor immediately to ensure problems are not repeated and existing issues are corrected. J-or L-rooting are especially common and serious mistakes that can be minimized with quality inspections (Fig. 6).

*Figure 5. Roots exposed for below-ground inspection without causing damage to the seedling*

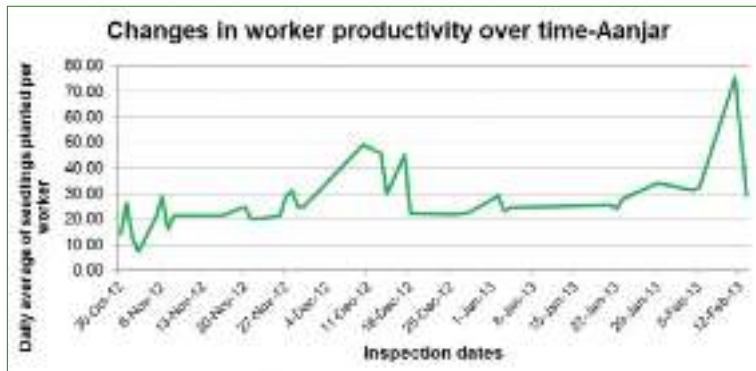
In 2012, daily inspection of planting quality allowed for better tracking of planting issues and quick on-site feedback and correction of mistakes. This led to a slight increase in worker productivity, mostly noticeable at the end of the planting season (Fig. 1-2). Below-ground planting quality also improved clearly during the season as a result of continuous feedback and daily briefing of planting workers (Fig. 1-3). Although J-rooting was still noticed in some seedlings, the rate was much lower than the previous year and decreased gradually during the planting season.

Figure 1-2. Changes in worker productivity in Aanjar during the planting season of 2012-2013 based on inspection data

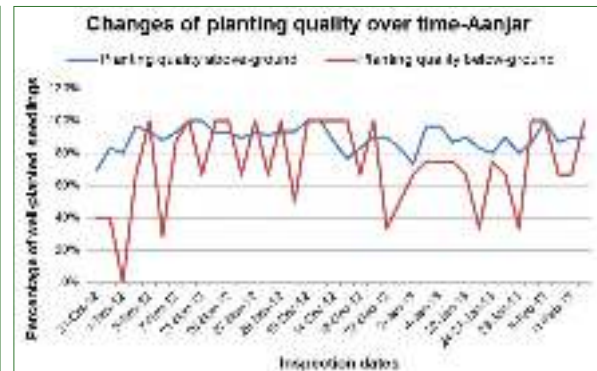
Figure 1-3. Changes in planting quality above and below ground in Aanjar during the planting season of 2012-2013 based on inspection data

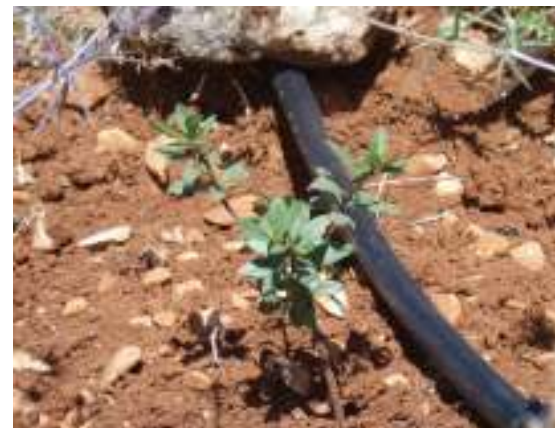
Figure 1-4. One-year-old seedling planted in Aanjar site in 2012 - photo taken in 2013 showing the drip irrigation system already set

In 2012-2013, weeds were scalped in the spring for around 1 m<sup>2</sup> around each seedling for a large proportion of the site. The irrigation system, installed the previous year, was used to irrigate the seedlings early into the dry season, which prevented any drought stress (Fig. 1-4).

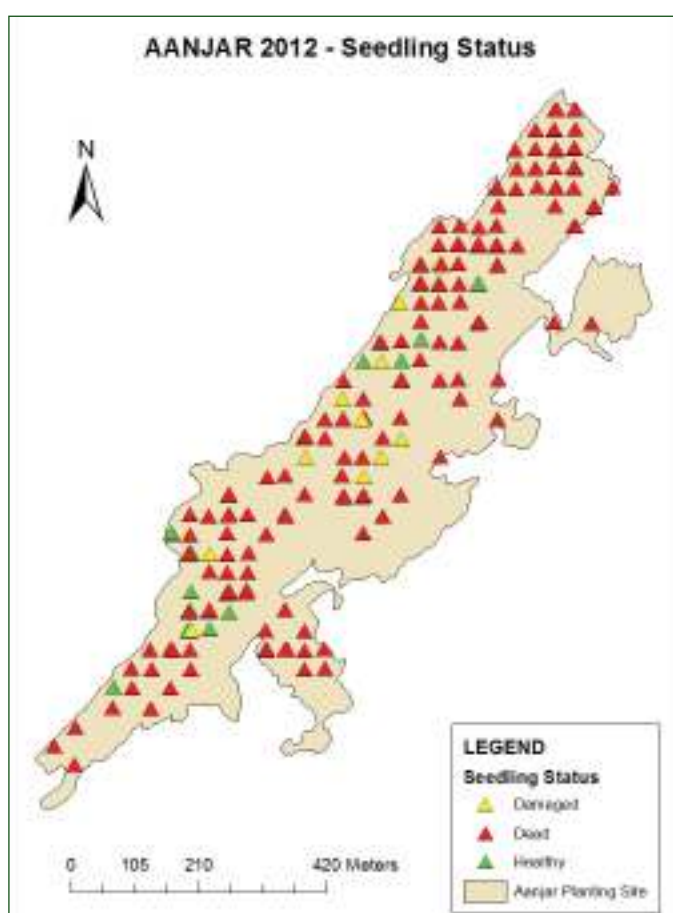
Figure 1-5. Seedling status map of Aanjar reforestation site based on the yearly monitoring data - summer 2012

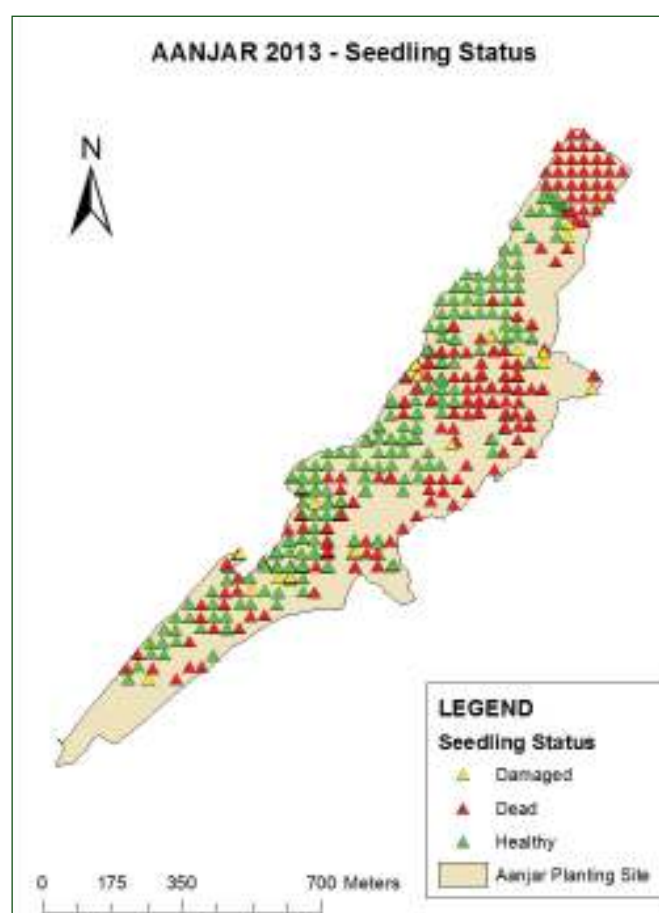
Figure 1-6. Seedling status map of Aanjar reforestation site based on the yearly monitoring data - summer 2013

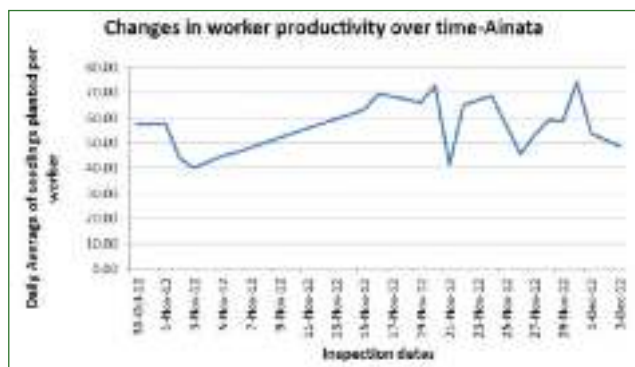
Planting quality was in general good for Ainata. As shown in figure 2-2, worker productivity increased during the planting season.

Figure 2-2. Changes in worker productivity in Ainata during the planting season of 2012-2013 based on inspection data

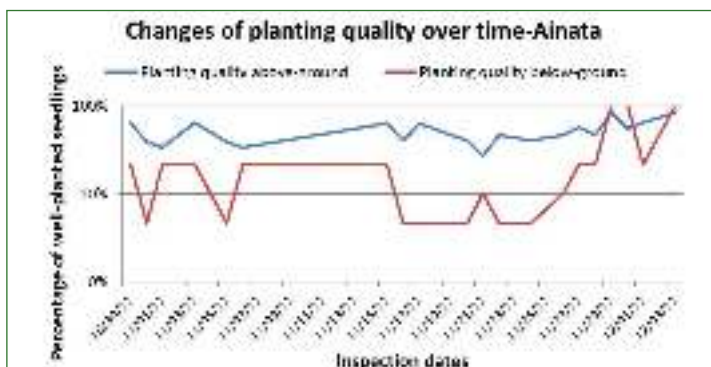
Figure 2-3. Changes in planting quality above and below ground in Ainata during the planting season of 2012-2013 based on inspection data

Below-ground mistakes done at the beginning of the season were fixed and planting quality improved considerably by early December 2012 (Fig 2-3). Overall, average planting quality above and below-ground was the same for both sites in Ainata (data not shown), suggesting that planting quality had no effect on seedling survival in this case.

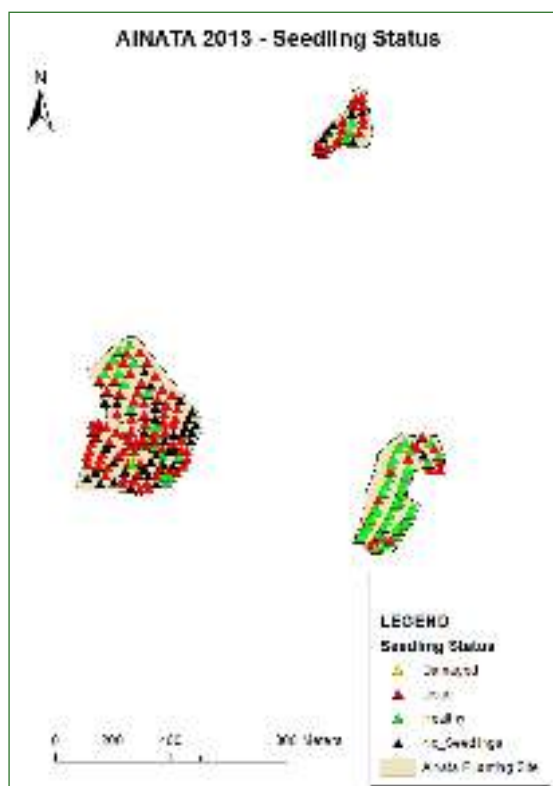
Figure 2-4. Seedling status map of Ainata reforestation site based on the yearly monitoring data - summer 2013

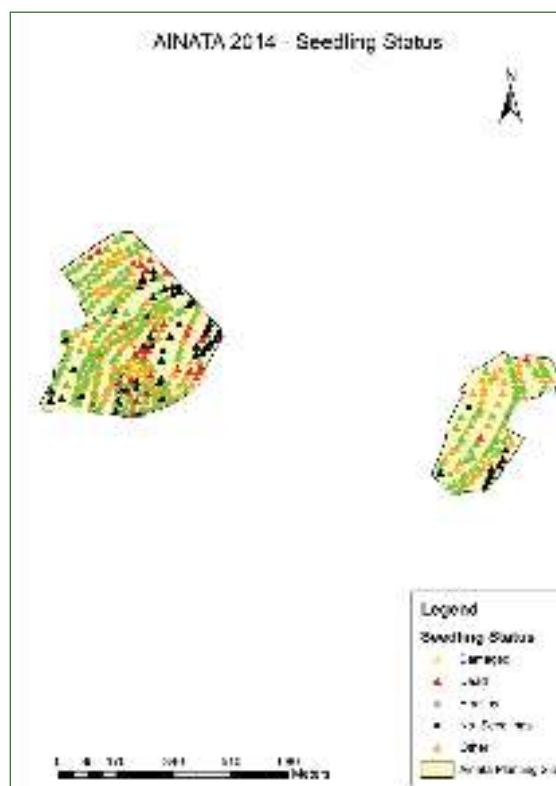
Figure 2-5. Seedling status map of Ainata reforestation site based on the yearly monitoring data - summer 2014

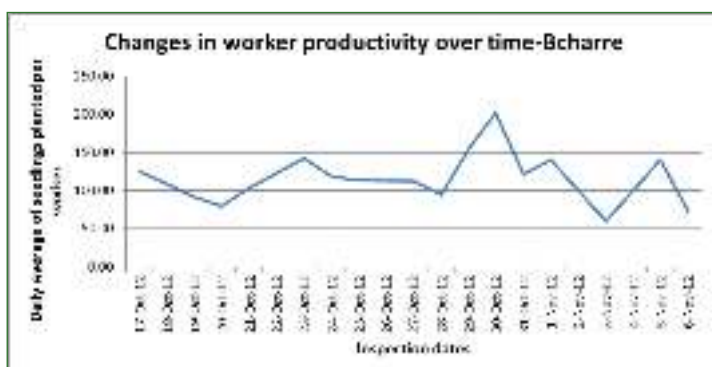
Planting quality averages were high in 2012, showing very good planting performance of the crew, in addition to their high productivity. As shown in figure 3-1, worker productivity fluctuated throughout the season, reaching 200 seedlings/worker/day in one day and never falling below the 50 seedlings/worker/day average productivity rate for LRI sites. This high productivity did not affect planting quality that improved fast after the first few days of planting and almost stabilized around 100% well-planted seedlings below ground and over 85% above ground (Fig. 3-2). Although planting quality was slightly lower in 2013, it did not seem to affect the seedling survival rate, which reinforces the potential effect of the change of inspector on result values.

Figure 3-1. Changes in worker productivity in Bcharre during the planting season of 2012-2013 based on inspection data

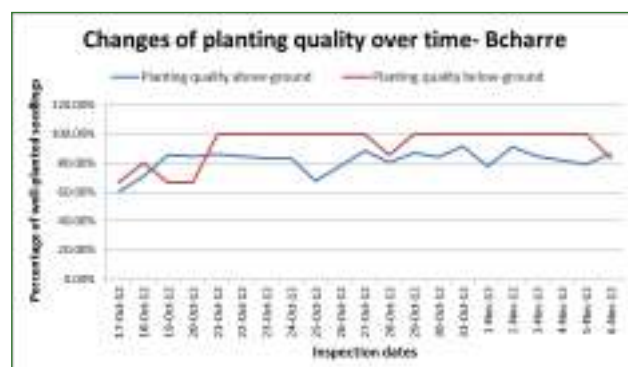
Figure 3-2. Changes in planting quality above ground and below ground in Bcharre during the planting season of 2012-2013 based on inspection data

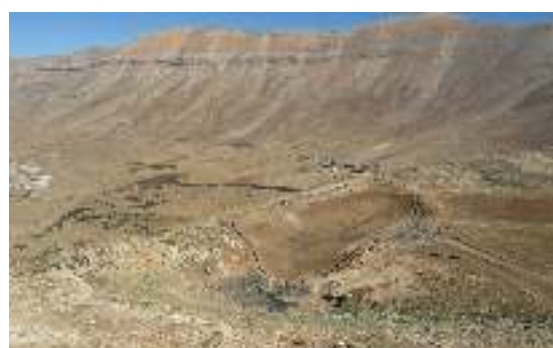
The site was irrigated from a pond made and maintained by CFC (Fig. 3-3). Irrigation was done by hand by the same contractor’s crew. Seedlings were irrigated four times in summer 2013 and CFC was supervising the irrigation to ensure all seedlings are well-irrigated.

Figure 3-3. Pond used to irrigate the surrounding planting site in Bcharre – photo taken in September 2012 before the lining and the irrigation system were added

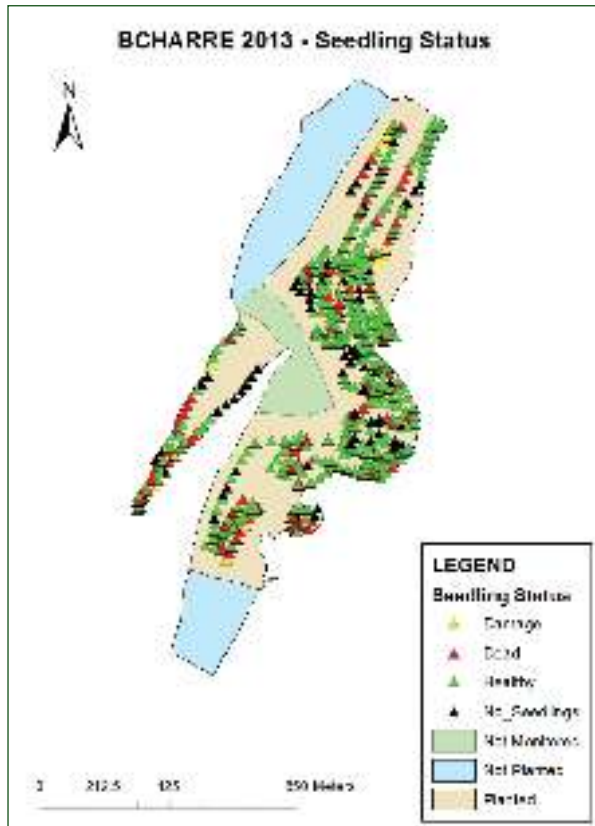
Figure 3-4. Seedling status map of Bcharre reforestation site based on the yearly monitoring data - summer 2013

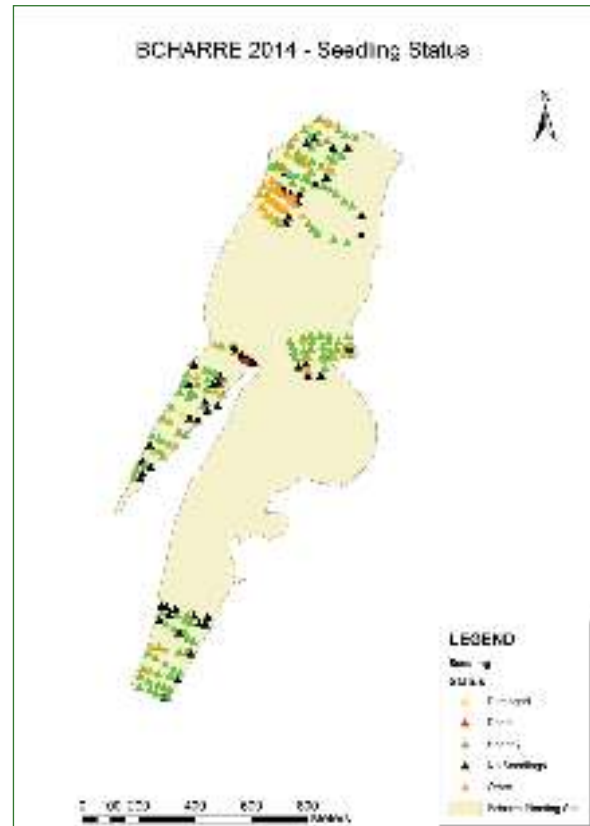
Figure 3-5. Seedling status map of Bcharre reforestation site based on the yearly monitoring data - summer 2014

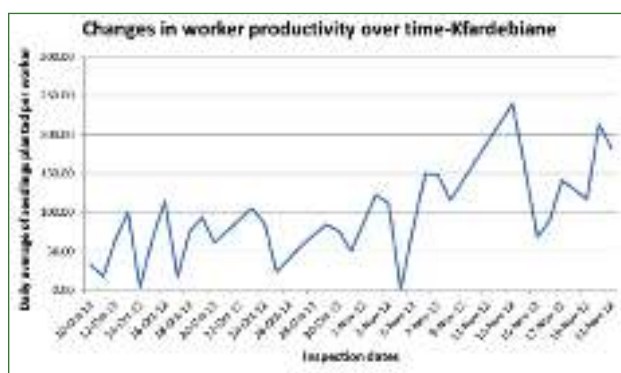
Average worker productivity was the second highest among all sites, also mostly due to the experience of the planting crew and the continuous presence of the supervisors. An improvement in worker productivity can be seen in November compared to earlier planting days in October 2012 (Fig. 4-1), reflecting the positive impact of daily planting inspections.

Figure 4-2. Changes in worker productivity in Kfardebiane during the planting season of 2012-2013 based on inspection data

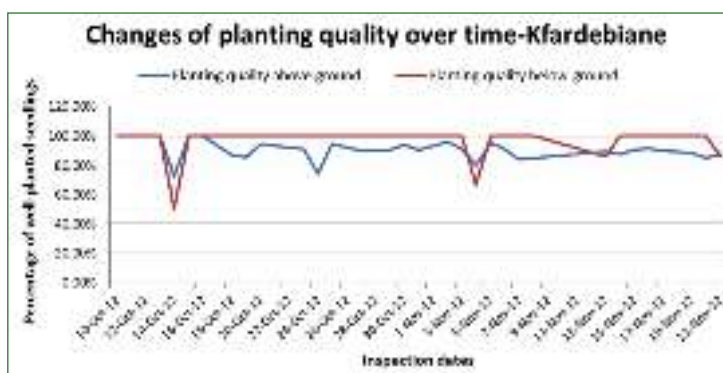
Figure 4-3. Changes in planting quality above- and below-ground in Kfardebiane during the planting season of 2012-2013 based on inspection data

Worker performance was very high, probably due to the long experience of the hired crews. The two peaks with lower planting quality, both above and below ground, shown in figure 4-2, correspond to days when volunteer activities were carried out. Major mistakes done on those days were later fixed by the hired planting crew.

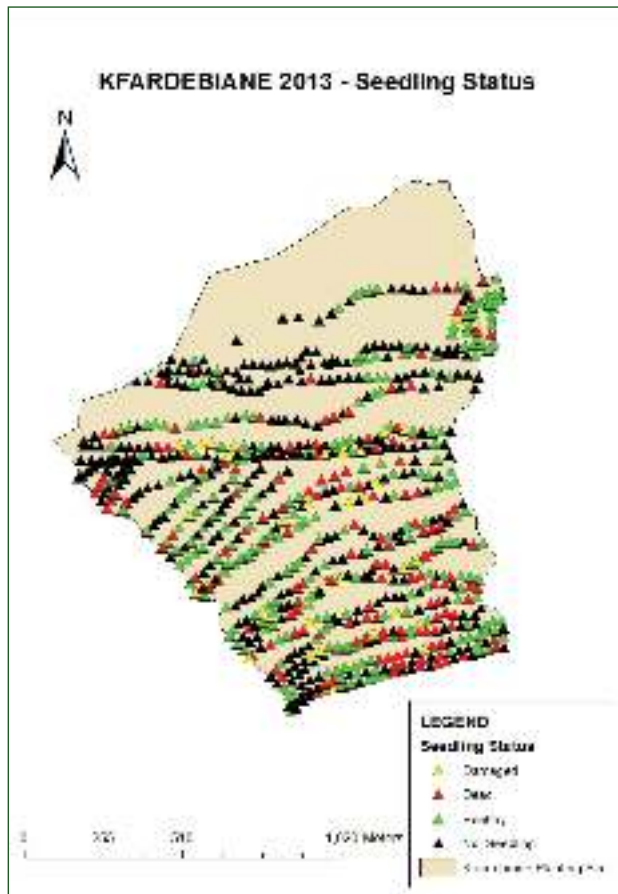
In summary, the 30% mortality observed in Kfardebiane is probably due to the combination of lower quality seedlings, inadequate seedling storage and transportation conditions, inadequate choice of species and drought. Grazing also contributed to the loss of about 2,000 seedlings.

Figure 4-6. Seedling status map of Kfardebiane reforestation site based on the yearly monitoring data - summer 2013

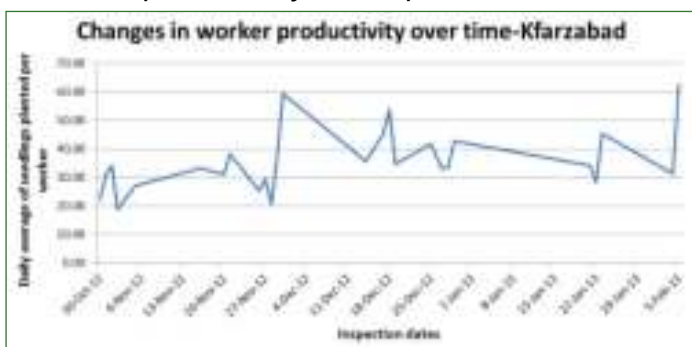
Planting inspection results in Kfarzabad showed a continuous fluctuation both in worker productivity (Fig. 5-2) and planting quality (Fig. 5-3). Notes of the inspector revealed a continuous turnover of crew members and a repetition of common mistakes despite the morning briefings and the daily feedback provided by the inspector.

Figure 5-2. Changes in worker productivity in Kfarzabad during the planting season of 2012-2013 based on inspection data

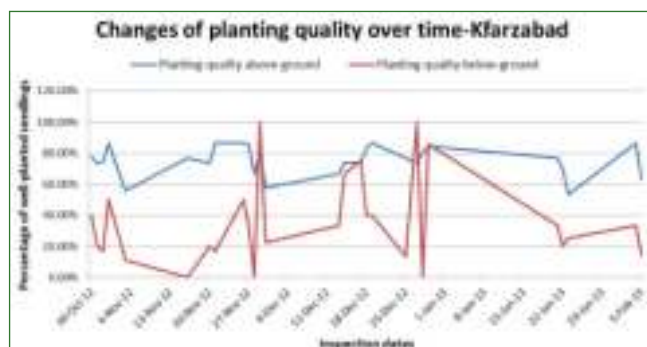
Figure 5-3. Changes in planting quality above and below ground in Kfarzabad during the planting season of 2012-2013 based on inspection data

Planting quality below ground was notably low, reaching 0% in some days, with a low average of 35%. Although the same planting inspector was working in both Aanjar and Kfarzabad, the impact of planting inspection was neutralized in Kfarzabad by the quick turnover of crew members and their very limited experience.

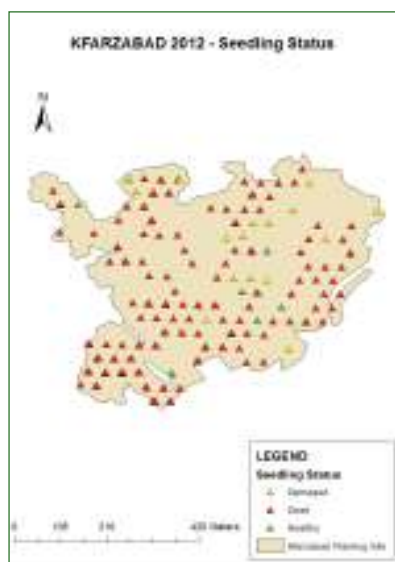
Figure 5-4. Seedling status map of Kfarzabad reforestation site based on the yearly monitoring data - summer 2012

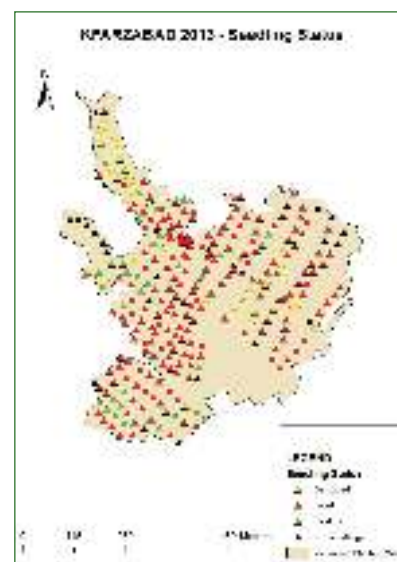
Figure 5-5. Seedling status map of Kfarzabad reforestation site based on the yearly monitoring data - summer 2013

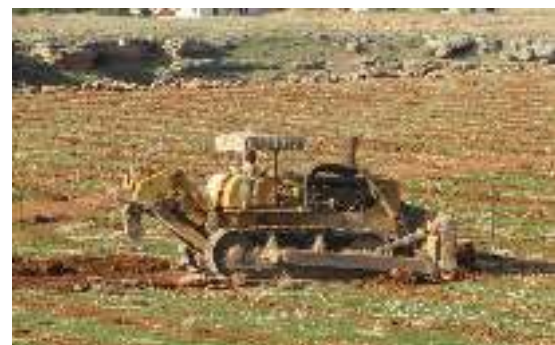
*Figure 6-1. Soil preparation of the Maqne site - photo shows the ripper used to remove the surface rocks and expose soil underneath. The pattern created is inevitably less random than with other techniques*

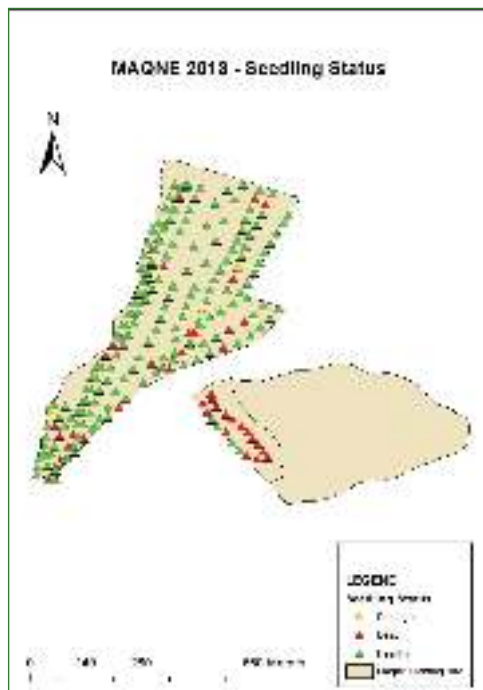
Figure 6-2. Seedling status map of Maqne reforestation site based on the yearly monitoring data - summer 2013

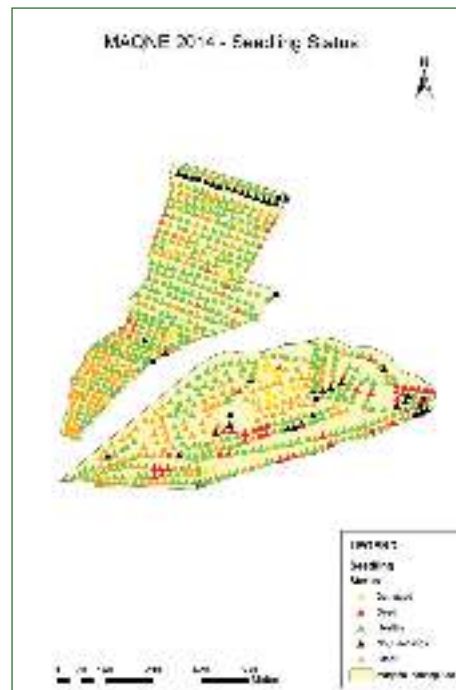
Figure 6-3. Seedling status map of Maqne reforestation site based on the yearly monitoring data - summer 2014

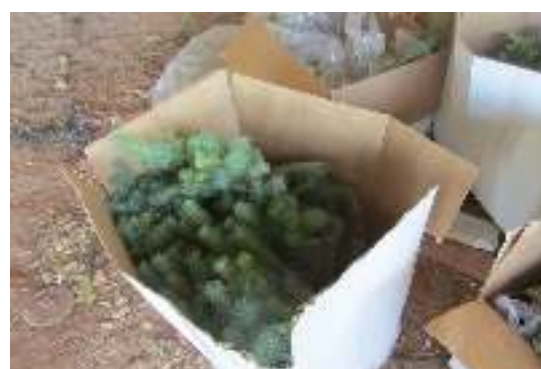
All seedlings produced in 2011 were not well-hardened, were stored and transported in plastic bags and cardboard boxes, and had high shoot-to-root ratios. On-site storage in Qlaiaa met the criteria needed to conserve seedling quality until planting time. Qlaiaa workers took extra care straightening seedlings when they were received and placing them upright in open bags (Fig. 7-1). This might explain the higher survival results in Qlaiaa compared to other sites planted in the same year with the same seedling quality, but where boxes were stored as received until planting time (e.g. Aanjar and Kfarzabad).

Figure 7-1. Seedlings placed in Qlaiaa storage space. All bags were opened upon arrival and placed straight inside their cardboard boxes

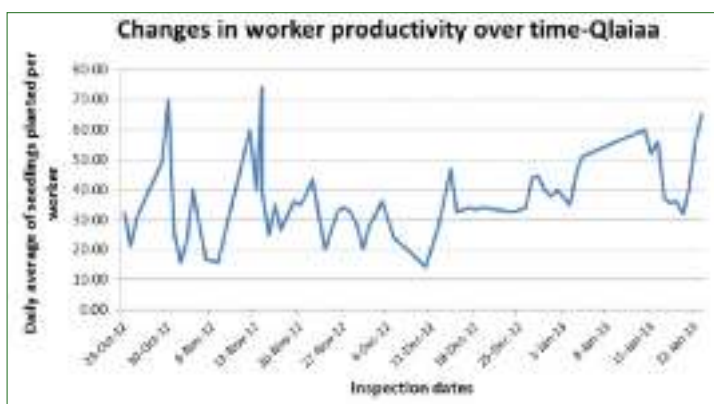
Worker productivity fluctuated during the fall season of 2012. No clear trend was observed and the overall average was within the range observed for all sites (Fig. 7-2).

Figure 7-2. Changes in worker productivity in Qlaiaa during the planting season of 2012-2013 based on inspection data

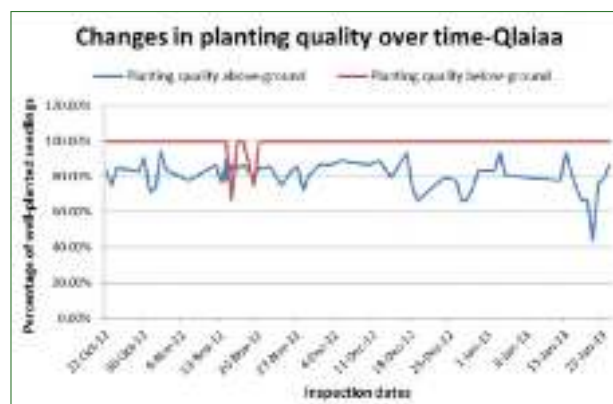
Planting quality was also high, with below-ground planting almost always at 100% (Fig. 7-3).

Figure 7-3. Changes in planting quality above- and below-ground in Qlaiaa during the planting season of 2012-2013 based on inspection data

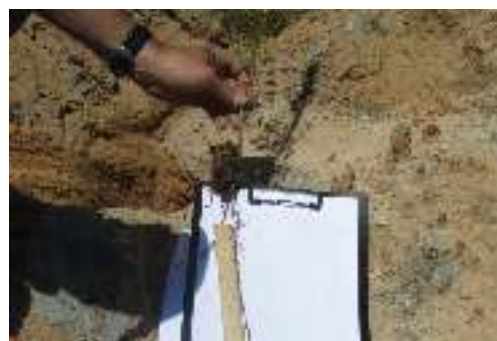
- The sandy soil of the quarry is easier for roots to develop than the clay-based soil of the “waer” site. Seedlings dug out in mid-May 2012 in the quarry had already developed roots more than 40cm deep (Fig. 7-4).

Figure 7-4. Seedling dug out on May 17th, 2012 from the Qlaiaa sand quarry site showing deep root growth

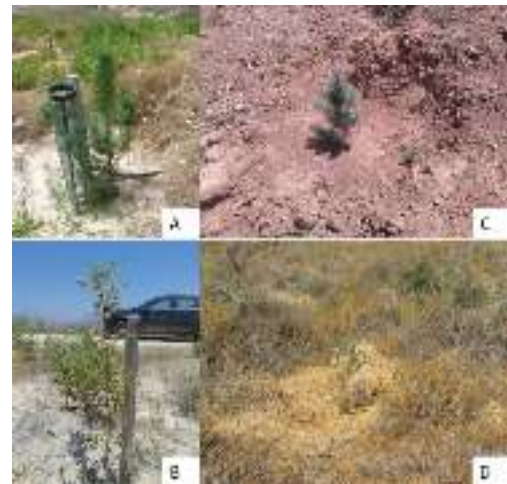
In addition to the high survival, seedling growth was notably faster in the Qlaiaa sand quarry compared to the “waer” or any other LRI site. Seedlings were reaching a meter of height less than two years after their planting date (Fig. 7-5).

Figure 7-5. Two-year-old seedlings in Qlaiaa quarry (A & B) and in Qlaiaa “waer” site (C & D). Shelter and wooden stakes are 90cm above-ground level

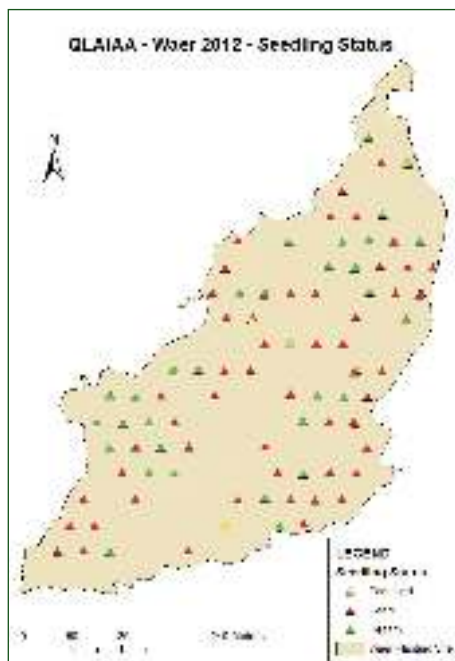
Figure 7-6. Seedling status map of Qlaiaa waer reforestation site based on yearly monitoring data - summer 2012

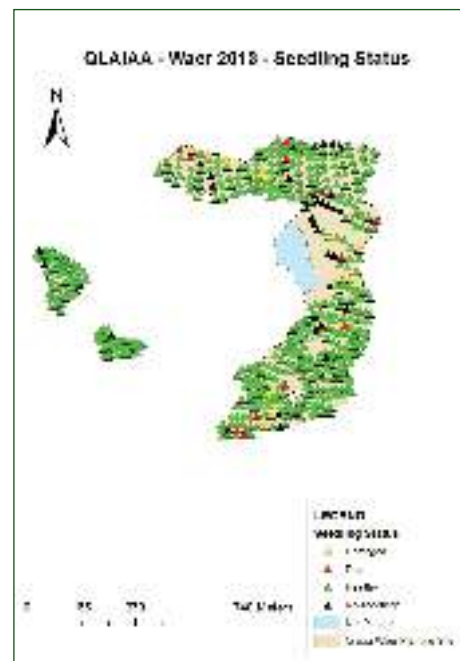
Figure 7-7. Seedling status map of Qlaiaa waer reforestation site based on yearly monitoring data - summer 2013

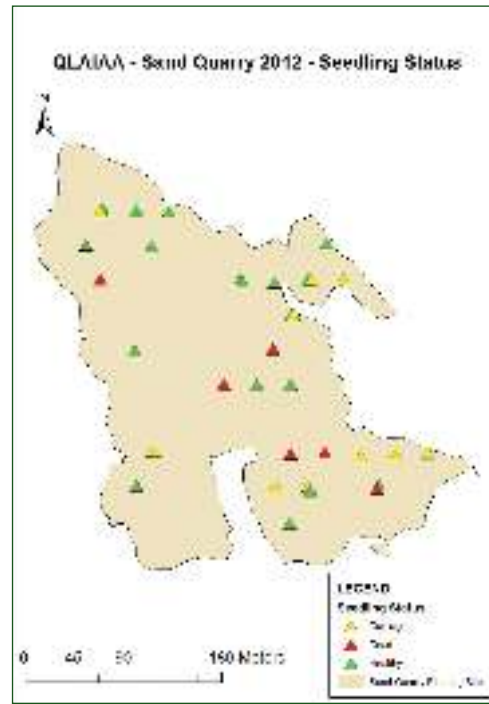
Figure 7-9. Seedling status map of Qlaiaa sand quarry reforestation site based on yearly monitoring data - summer 2012

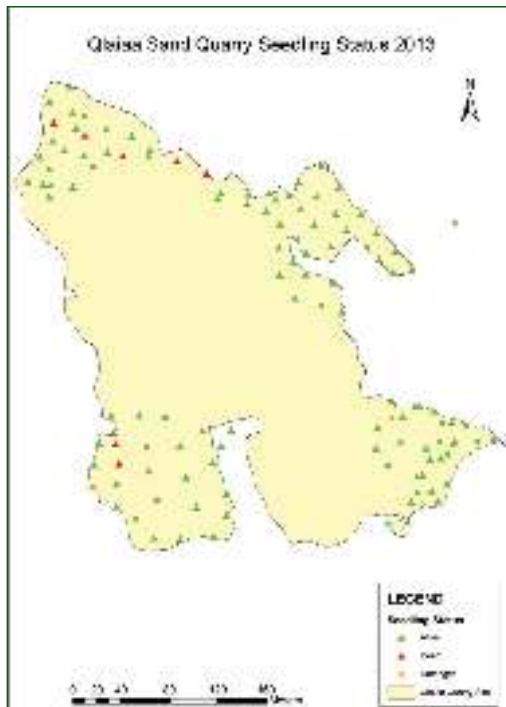
Figure 7-10. Seedling status map of Qlaiaa sand quarry reforestation site based on yearly monitoring data - summer 2013

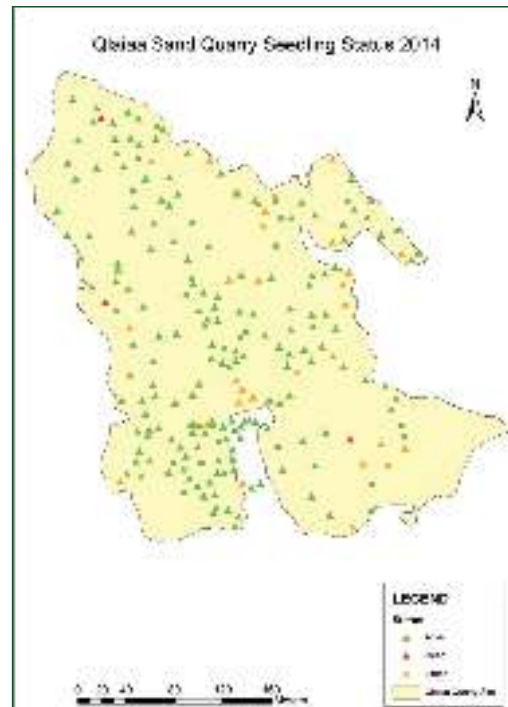
Figure 7-11. Seedling status map of Qlaiaa sand quarry reforestation site based on yearly monitoring data - summer 2014

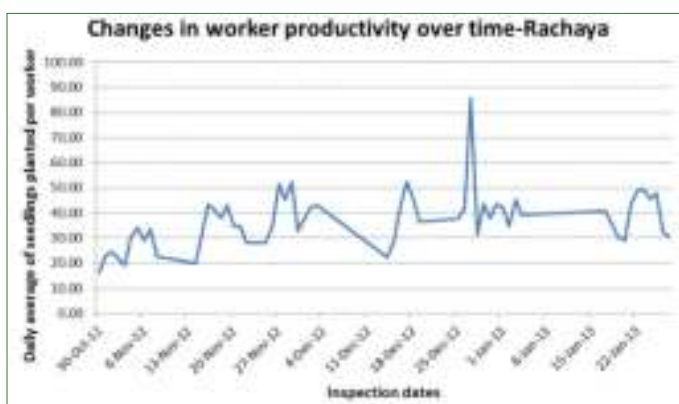
Worker productivity fluctuated around the same average for all of the planting season of 2012 and 2013 (Fig. 8-1). The major reasons for the low average were two fold: the topography of the site required a considerable amount of effort for workers to navigate and plant the site; and workers in Rachaya were experienced farmers who took special care of every seedling planted, resulting in high planting quality at the expense of productivity (Fig. 8-2).

Figure 8-1. Changes in worker productivity in Rachaya during the planting season of 2012-2013 based on inspection data

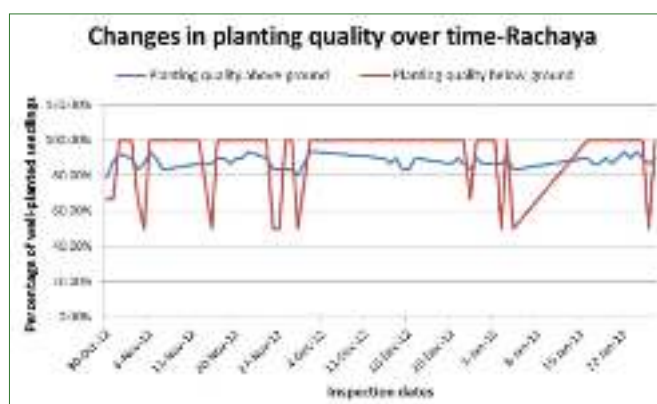
Figure 8-2. Changes in planting quality above- and below-ground in Rachaya during the planting season of 2012-2013 based on inspection data

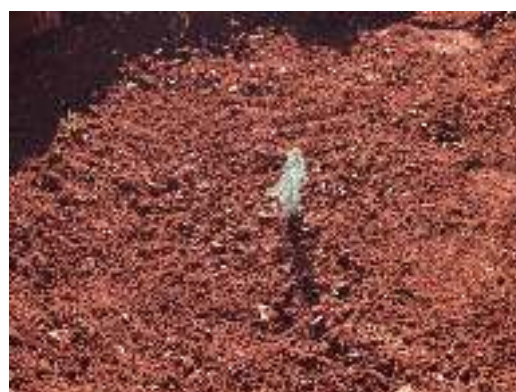
In Rachaya, weeds constituted a serious issue. Rachaya is also classified as a high risk fire area on the Lebanese fire risk map (AFDC, 2014)<sup>2</sup>. Scalping was performed in Rachaya since the first year (Fig 8-3). Trials on using different types of mulching were also done in several plots in the site over the three years (Fig. 8-4).

Figure 8-3. Complete scalping around pine seedling planted in Rachaya reforestation site

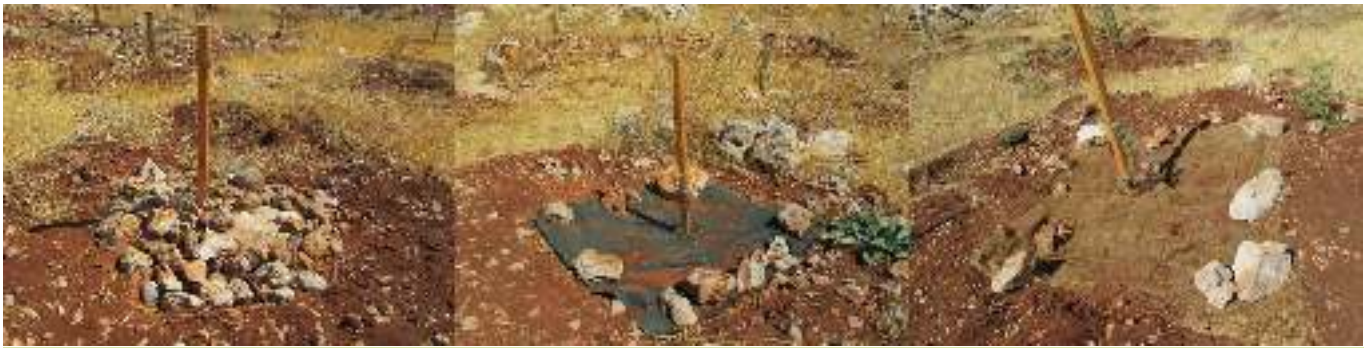
Figure 8-4. Different mulching options tried in Rachaya in 2012. From left to right: stone mulching, plastic mulch mat, and fabric mulch mat

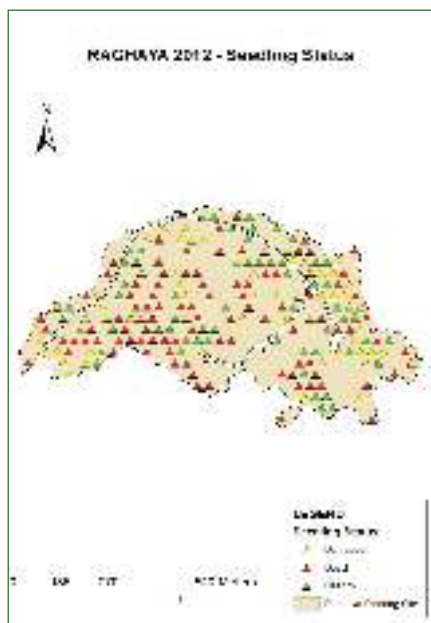
As in all LRI sites for the first year of planting, installing the irrigation system was delayed. In fact, Rachaya was the last site to have its irrigation system installed. The site was irrigated almost all summer with water trucks. Delays in irrigation and the known inefficacy of irrigating with water trucks that could not access the whole site could have contributed significantly to the amount of mortality observed in summer 2012 (see Fig. 8-5).

Figure 8-5. Seedling status map of Rachaya reforestation site based on yearly monitoring data - summer 2012

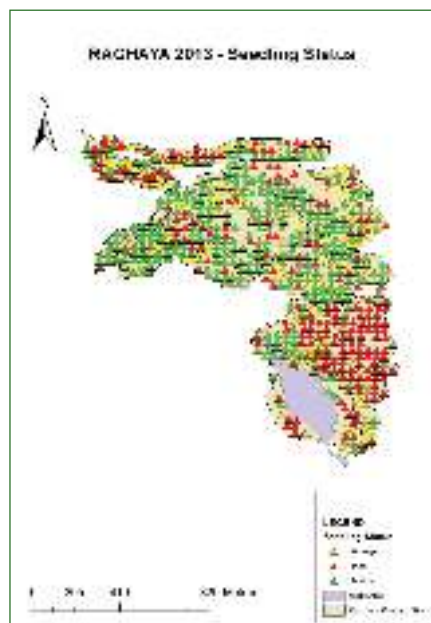
In 2013, all the area planted in 2011 had a drip irrigation system set. However, the extension of the site planted in fall 2012 did not get a drip irrigation system and was irrigated manually or with water trucks. The concentration of high mortality in those specific areas (see Fig. 8-6) that received less irrigation reinforces the hypothesis that irrigation played a primary role in the mortality rates observed in Rachaya. That area was replanted in fall 2013.

Figure 8-6. Seedling status map of Rachaya reforestation site based on yearly monitoring data - summer 2013

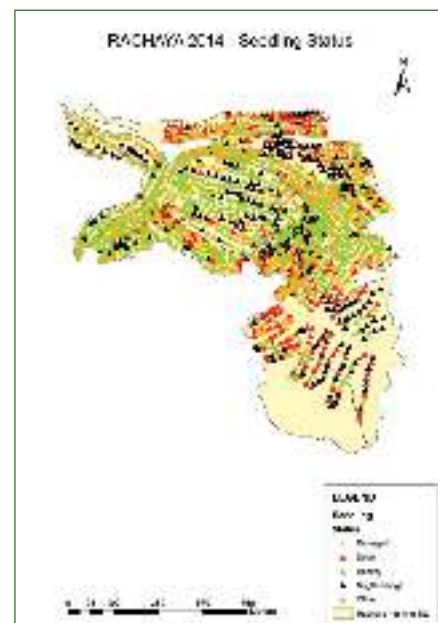
Figure 8-7. Seedling status map of Rachaya reforestation site based on yearly monitoring data - summer 2014

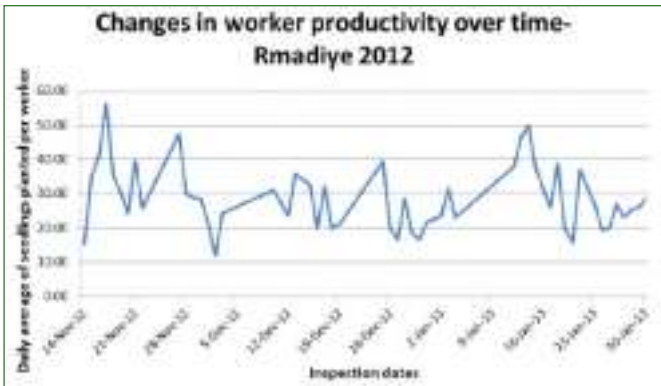
Unlike other sites where worker productivity increased through the season, inspection of planting quality in the fall seasons of 2012-2013 and 2013-2014 showed a rather stagnant or even slightly decreasing worker productivity average over time (Fig. 9-1 and 9-2). This was due mostly to the quick turnover of workers for both seasons and to the hard topography and limited access to the site that required walking for long distances to reach the planting area.

Figure 9-1. Changes in worker productivity in Rmadiye during the planting season of 2012-2013 based on inspection data

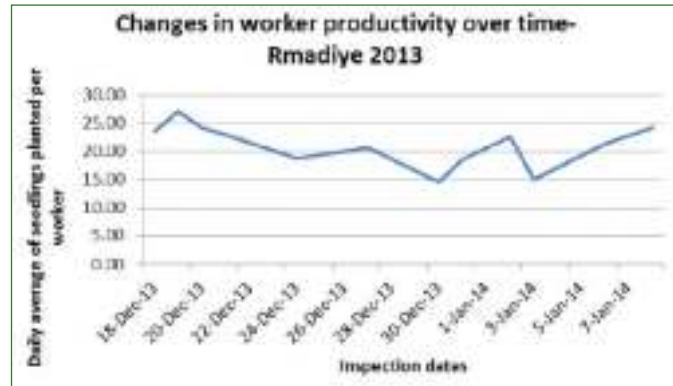
Figure 9-2. Changes in worker productivity in Rmadiye during the planting season of 2013-2014 based on inspection data

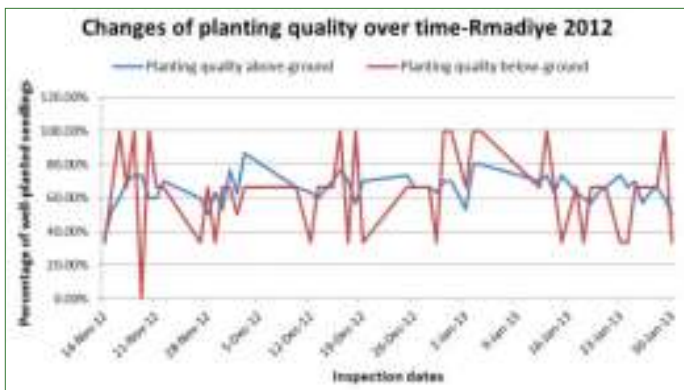
In the first planting season, planting quality was variable day-to-day in Rmadiye, but fluctuating around the same average (Fig. 9-3). Rocks in the planting hole and J-rooting were among the most common planting mistakes done. Shallow planting was also common.

Figure 9-3. Changes in planting quality above and below-ground in Rmadiye during the planting season of 2012-2013 based on inspection data

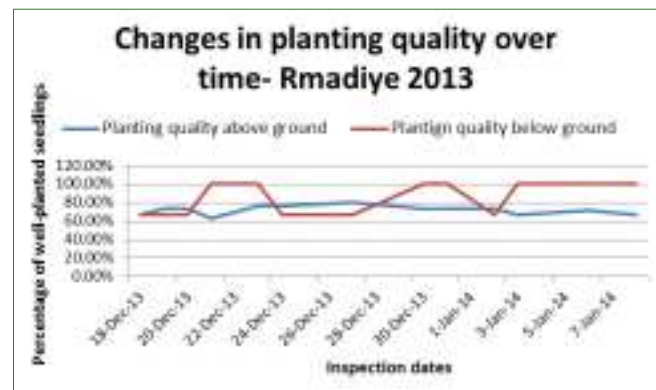
In the planting season of 2013-2014, planting quality was constantly high with a slightly increasing trend for below-ground planting, reaching 100% well-planted seedlings most of the time (Fig. 9-4).

Figure 9-4. Changes in planting quality above and below-ground in Rmadiye during the planting season of 2013-2014 based on inspection data

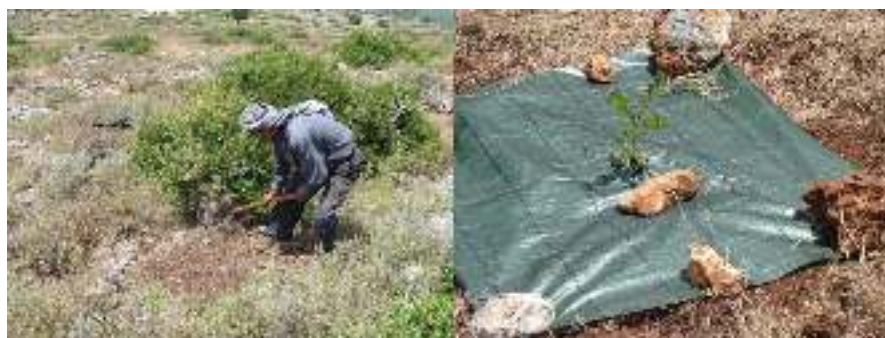
In Rmadiye, weed management procedures included scalping and mulching (see examples in Fig. 9-5 below).

Figure 9-5. Weed management procedures used in Rmadiye including scalping (left) and mulching (right)

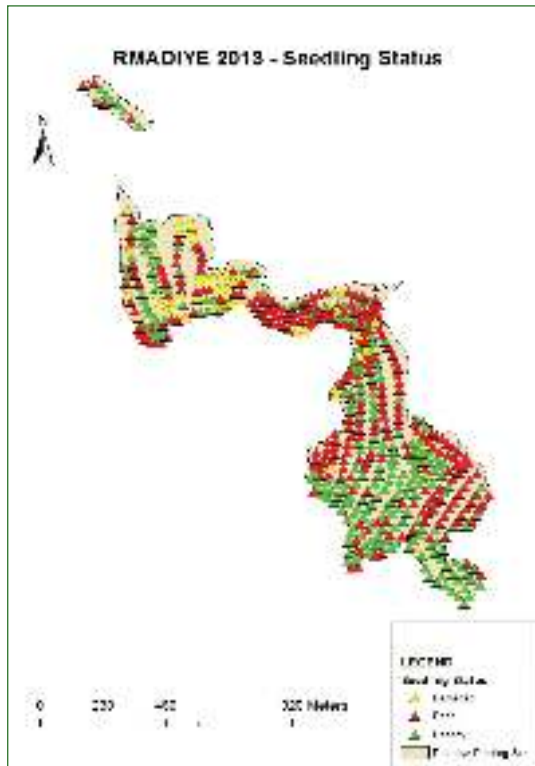
Figure 9-7. Seedling status map of Rmadiye reforestation site based on the yearly monitoring data - summer 2013

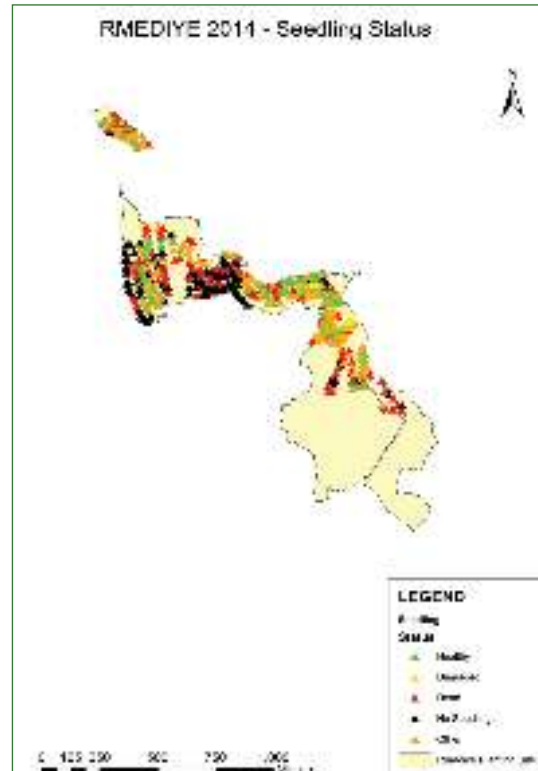
Figure 9-8. Seedling status map of Rmadiye reforestation site based on the yearly monitoring data - summer 2014

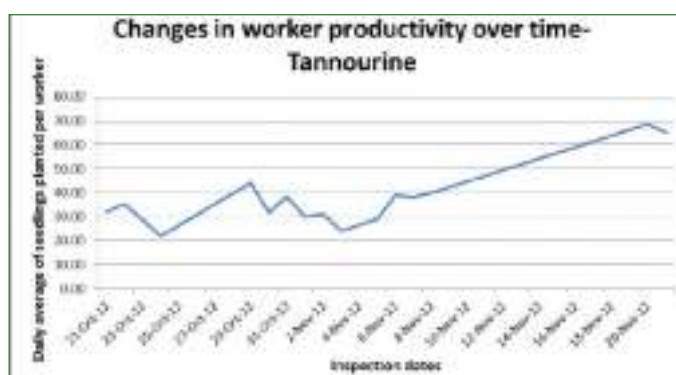
Worker productivity in Tannourine increased remarkably during the planting season (Fig 10-2) and planting quality averages were quite high (Fig. 10-3 and Table 10-3), which suggests that the mortality observed in 2013 on the site is not directly linked to planting quality.

Figure 10-2. Changes in worker productivity in Tannourine during the planting season of 2012-2013 based on inspection data

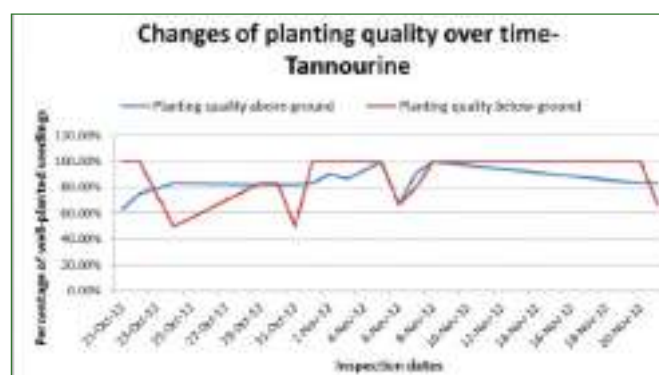
Figure 10-3. Changes in planting quality above- and below-ground in Tannourine during the planting season of 2012-2013 based on inspection data

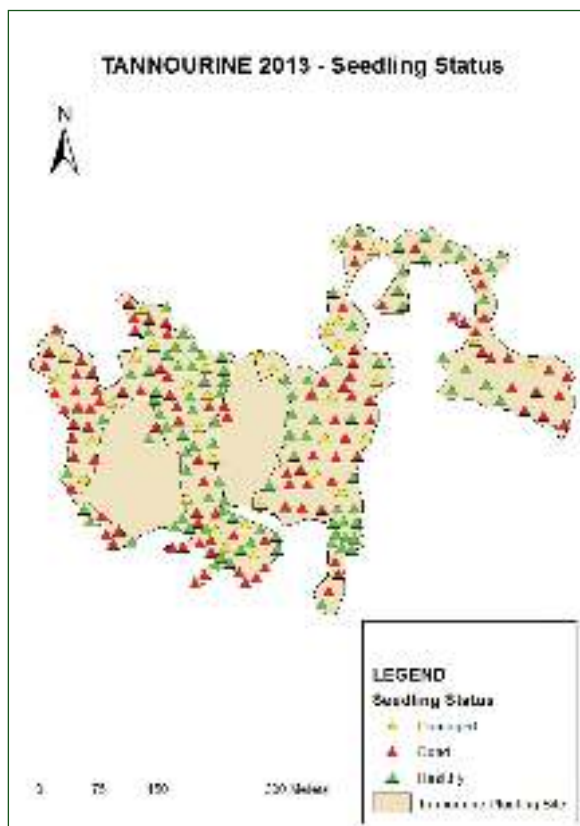
Figure 10-4. Seedling status map of Tannourine reforestation site based on the yearly monitoring data - summer 2013

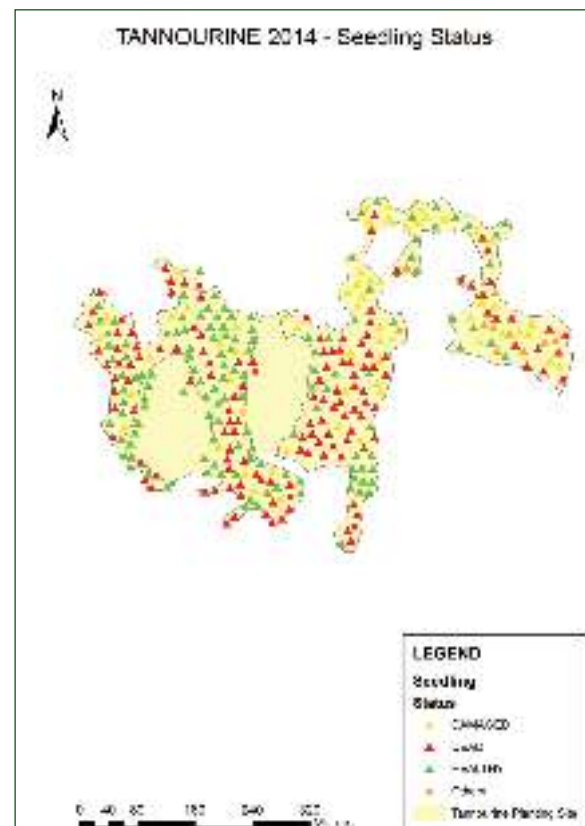
Figure 10-5. Seedling status map of Tannourine reforestation site based on the yearly monitoring data - summer 2014

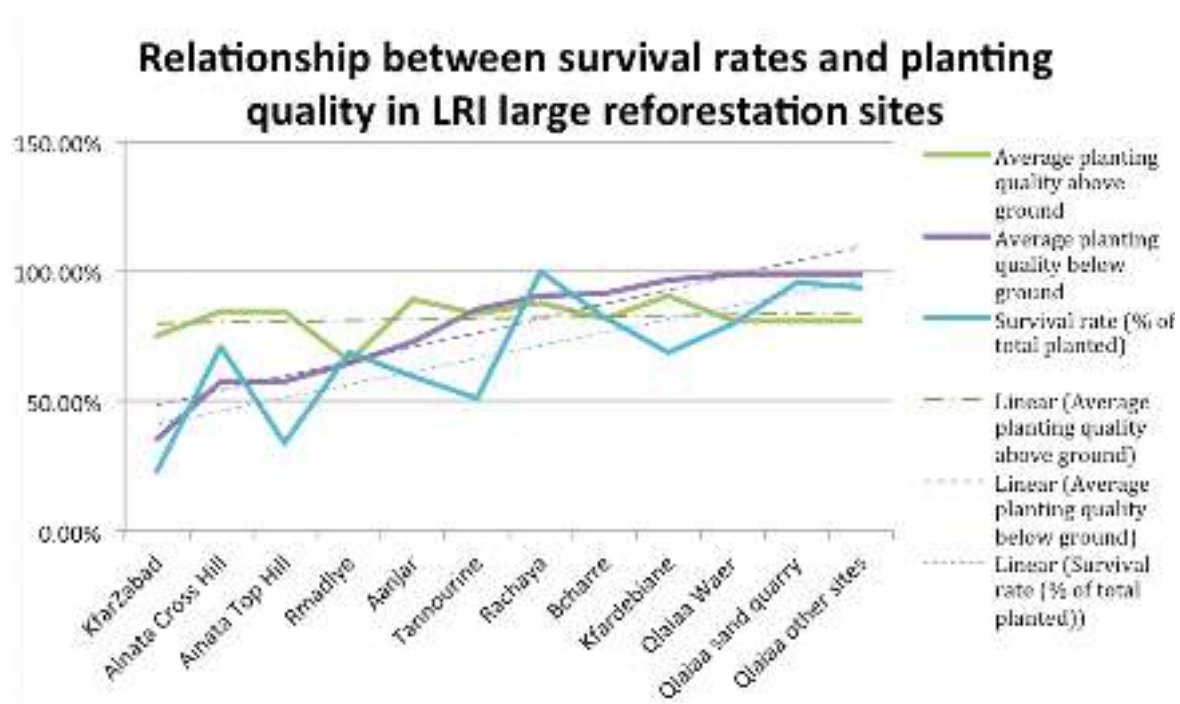
Planting quality inspection and monitoring of seedling survival were not conventionally used in reforested areas across Lebanon. The purpose of this document was to share the protocols used by LRI for these two practices with reforestation stakeholders and to show the importance of the data collected through both processes for drawing lessons learned and improving the decision-making process for future projects. Planting quality inspection was found in most sites to have the additional advantage of influencing planting quality within the same planting season and consequently improving seedling survival rates. In fact, across all LRI sites, a clear relationship was observed between below-ground planting quality and seedling survival whereby sites with better planting quality at the root level exhibited higher survival rates (Fig. IV-1).

Figure IV-1. Graph showing relationship between survival rates and planting quality results in LRI large reforestation sites for the planting season of 2012-2013
