Environmental Emergency Response to the Lebanon Crisis

***Consolidated report on activities undertaken through
the Joint UNEP/OCHA Environment Unit***

November 2006

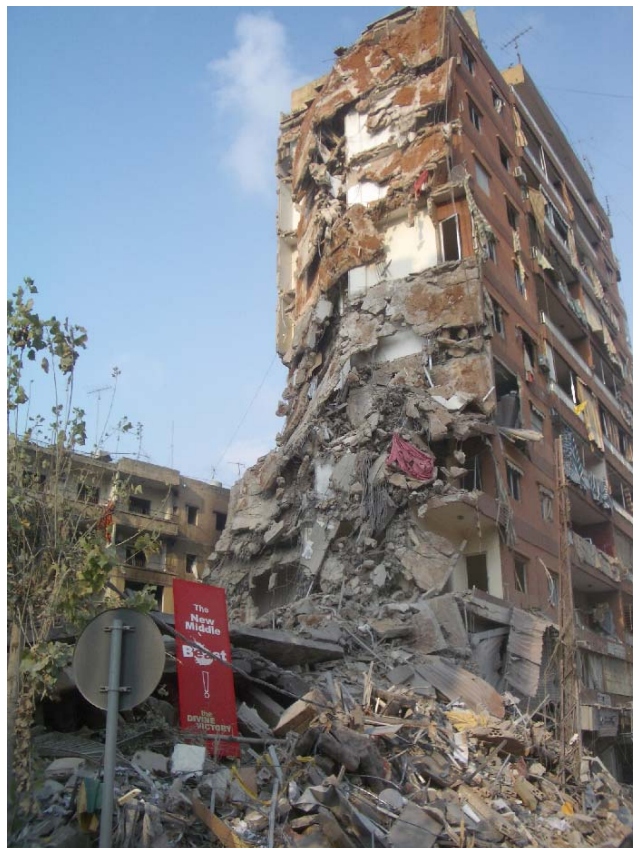
A rapid waste assessment helped determine identify the composition of waste and supported response planning. Source: R. Nijenhuis

Rapid waste assessment. A waste management expert of the Swiss Agency for Development and Cooperation (SDC) was deployed through the Joint Environment Unit to assist the Ministry of Environment with a rapid waste assessment. The assessment focussed on the volume and composition of waste in the southern suburbs. The possible presence of unexploded ordnance (UXO) in the rubble was thought to pose a serious risk and the greatest impediment to clearing and demolition activities. Most buildings in the area visited were between 6 and 10 floors, and built of concrete re-enforced by steel. A rough estimate of the debris composition (in percentage) from this assessment is noted in Table 1. In some areas visited, an estimated that 80% of the buildings were completely destroyed. The assessment did not detect toxic gases or radioactivity above expected background levels.

Based on this assessment, recommendations were made to the Ministry of Environment for the establishment of a temporary waste recycling and storage sites in order to promote the recycling of various waste streams. The objective was to reduce the pressure on natural resources, including the negative impacts of quarrying in Lebanon.

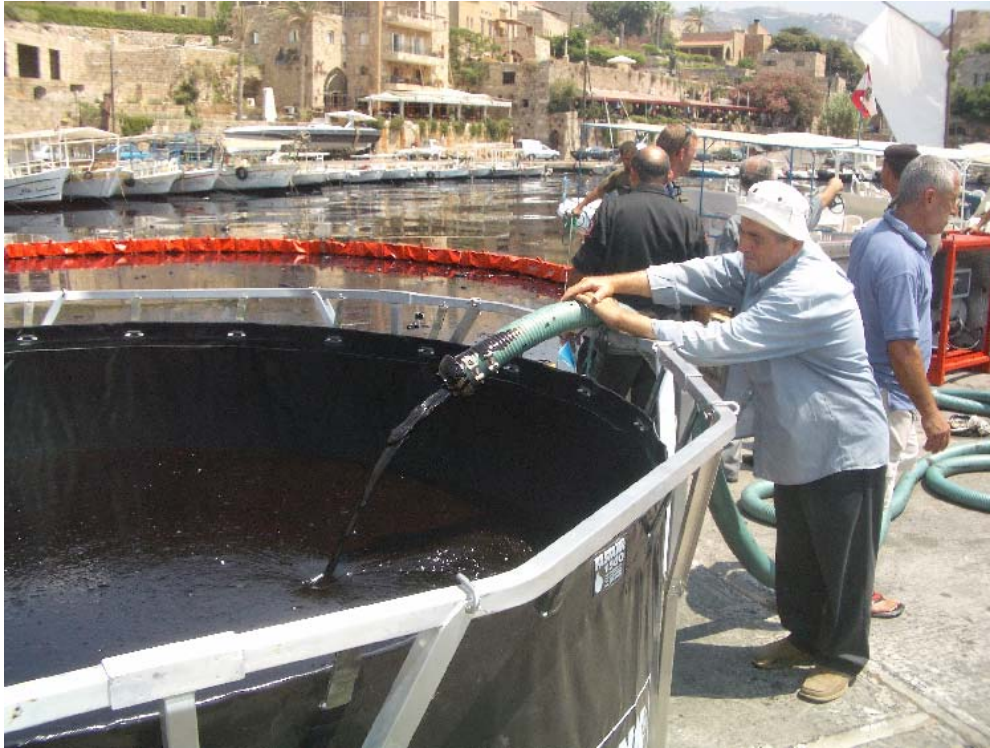
Oil spill clean-up activities in Lebanon: acute needs have been met, but longer-term challenges remain. Source: R. Nijenhuis
