REPUBLIC OF LEBANON  
MINISTRY OF ENVIRONMENT

# **UPDATED MASTER PLAN FOR THE CLOSURE AND REHABILITATION OF UNCONTROLLED DUMPSITES THROUGHOUT THE COUNTRY OF LEBANON**

Volume A

JUNE 2017

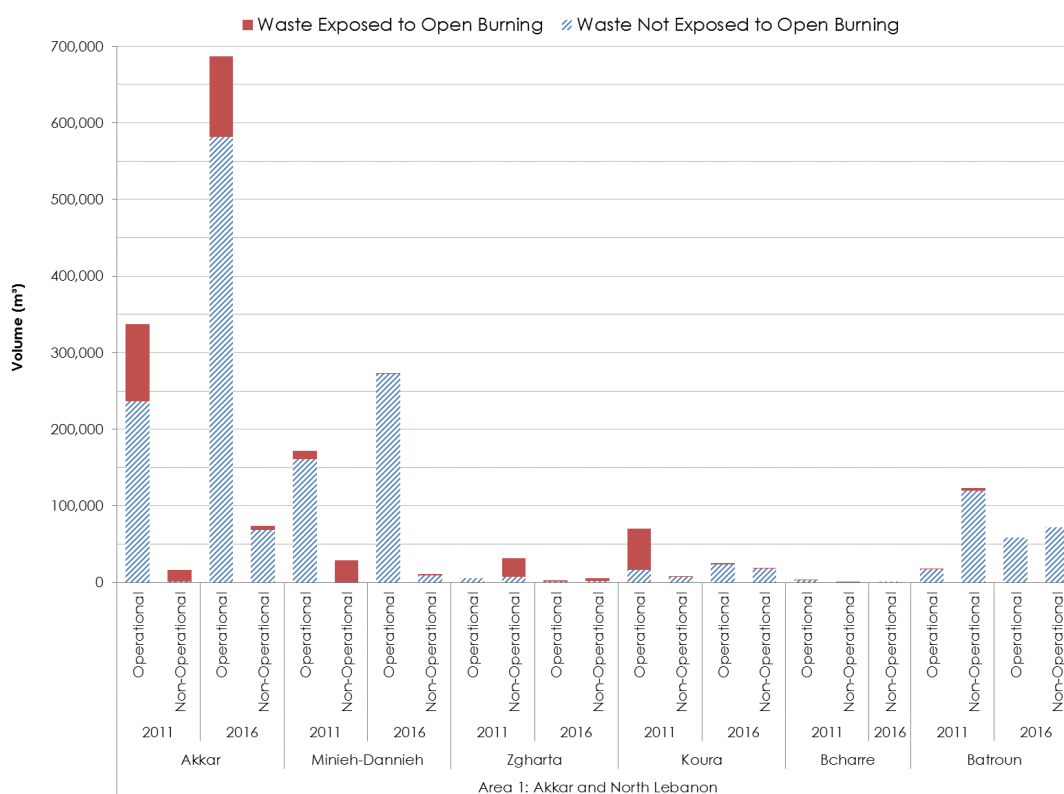
**Figure 3-5 Volume of MSW in Relation to Dumpsite Status and Exposure to Open Burning in 2011 and 2016 in 'Area 1: Akkar and North Lebanon'**

There is a general increase in the volume of MSW disposed of in uncontrolled dumpsites in 'Area 1: Akkar and North Lebanon'. A decrease in burning practices in Area 1 in the 2016 survey was observed overall with respect to the 2011 survey as shown in Figure 3-5.
